**Regarding: 03V-309 Expansion of Recall
 1999 through 2001 Model Year Yamaha XV1600
 Transmission Factory Modification Campaign**

Technical BULLETIN

RECALL

1999~2001 XV16 MODELS FACTORY MODIFICATION CAMPAIGN

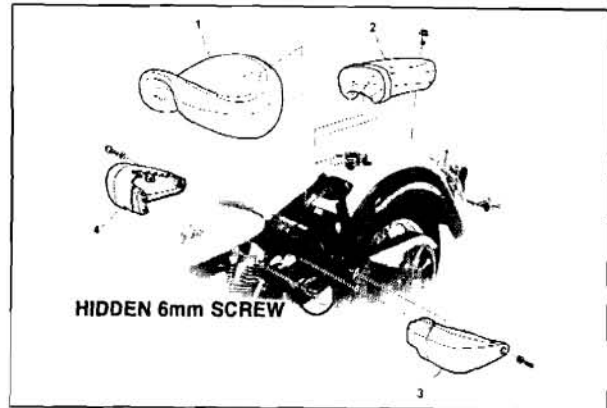
Side Cover Removal:

Before attempting to remove the right side cover, remove the left cover first to access the hidden 6mm bolt.

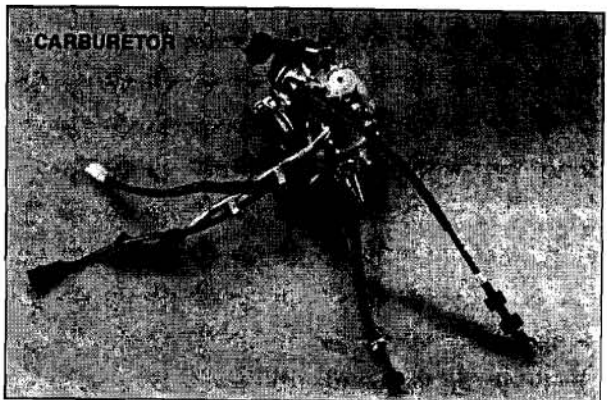
Fuel Pump and Carburetor Removal:

- Disconnect the carburetor fuel line hose at the fuel pump.
- Disconnect the fuel pump wire coupler.
- Remove the choke cable from fuel pump bracket.
- Remove the upper engine mount, leaving the fuel pump attached to the mount.
- Disconnect the TPS and carburetor wire couplers. Disconnect the throttle cables, and then remove the carburetor.

NOTE: The idle adjuster can be removed from its bracket without loosening the bracket screws.

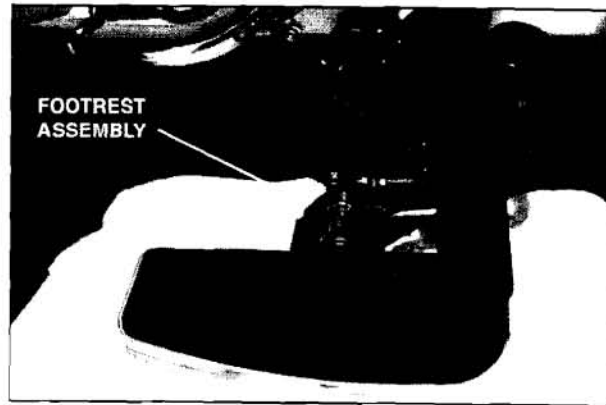
Right-Hand Footrest Removal:

- Disconnect and remove the brake light switch.
- Remove the forward-most tie wrap around the brake hose and frame.
- Remove the footrest assembly.

NOTE: Leave the brake hose attached. Move the hose to the underside of the foot rest mount and support it as necessary so that it is out of the way

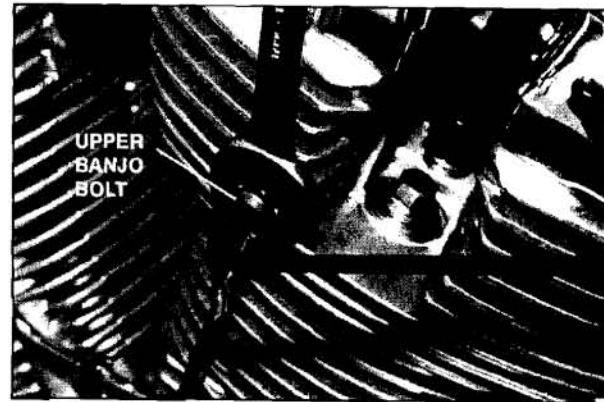
Cylinder Head Oil Pipe Removal/ Installation:

- Slightly loosen all three banjo bolts before removing them to prevent oil line deformation.

NOTE: When loosening the upper banjo bolts, hold the line in place using a wrench at the flat surface on the fitting.

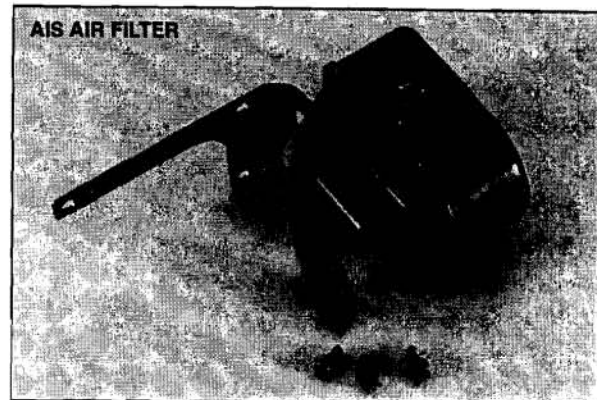
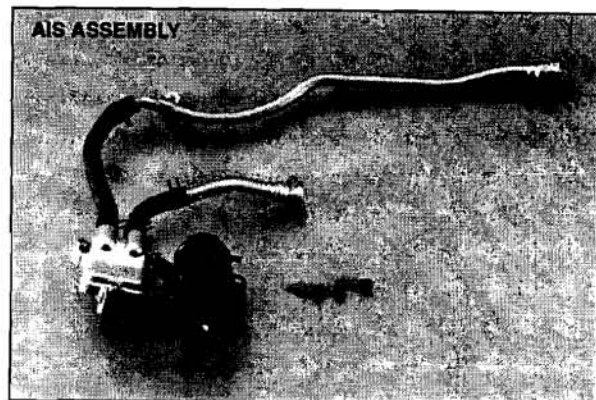
Air Injection System (AIS) Removal:

- Remove the electric starter motor.
- Remove the regulator/rectifier assembly. Remove the AIS pipes from the cylinder head, but leave them attached to the AIS assembly.
- Remove the three screws with 8mm heads, and then remove the AIS air filter from the right side.
- Remove the three Phillips head screws holding the AIS assembly on the frame.
- Remove the AIS assembly from the left side.

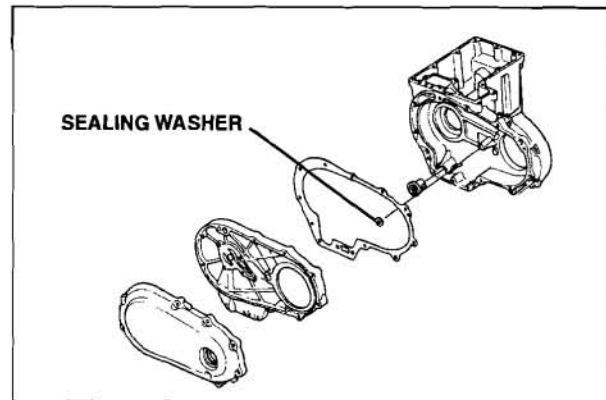
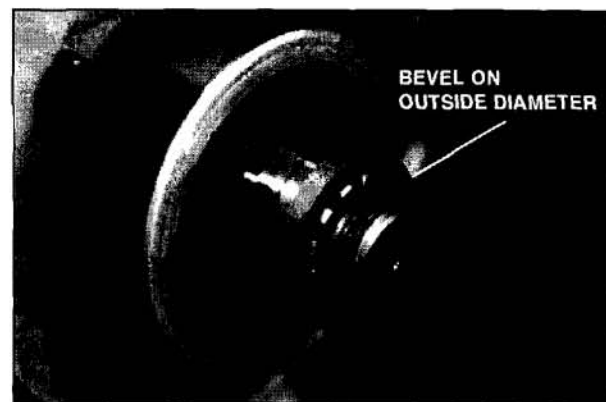
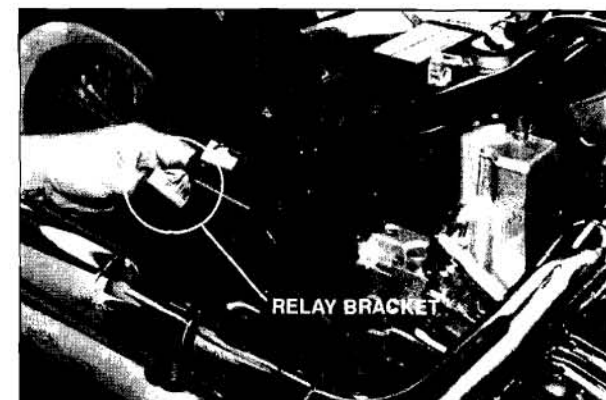
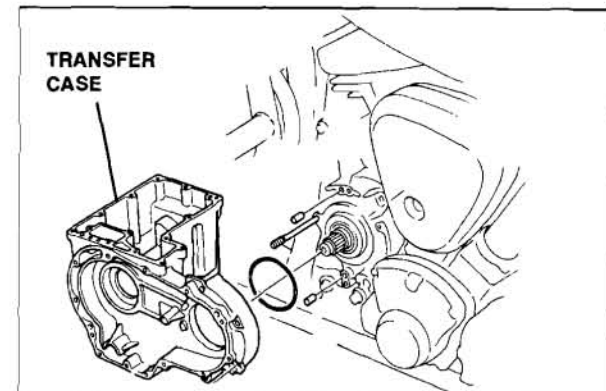
Transfer Case Removal:

- Remove the transfer case bracket first. Then remove the outer chrome cover, inner cover, and drive-sprocket nut.

NOTE: There is a sealing washer between the inner case and the transfer case at the 8mm stud. Be sure to replace it during re-assembly.

- Remove the drive pulley cover and remove the drive pulley nut.
- Loosen the drive belt tension.
- Remove the drive pulley, inner cover, collar, and O-ring.

NOTE: The collar has a bevel on its inside diameter for the O-ring facing inward and a bevel on the outside diameter facing the pulley.

- Remove the drive and driven sprockets with chain as an assembly.
- Remove the collar and O-ring.

- Slide the transfer case out from the right side.

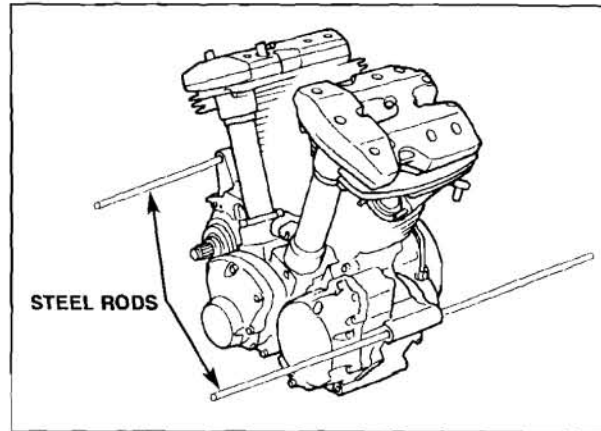
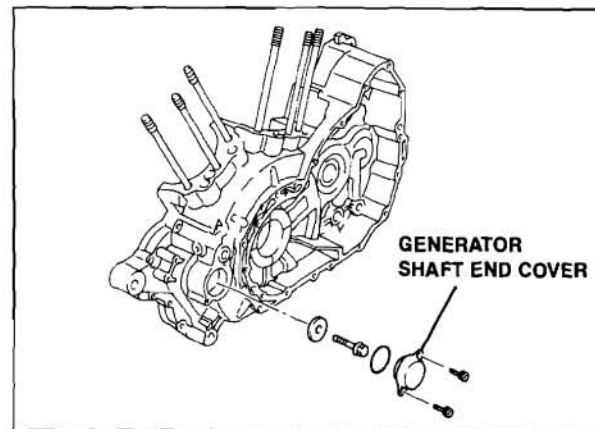
Engine Tear Down:

- Remove the left-hand generator shaft end cover and remove the generator shaft bolt and washer.
- Remove the clutch, primary drive gear, shift shaft, shift detent, oil pump gear and oil crossover pipe.

- Remove both top ends

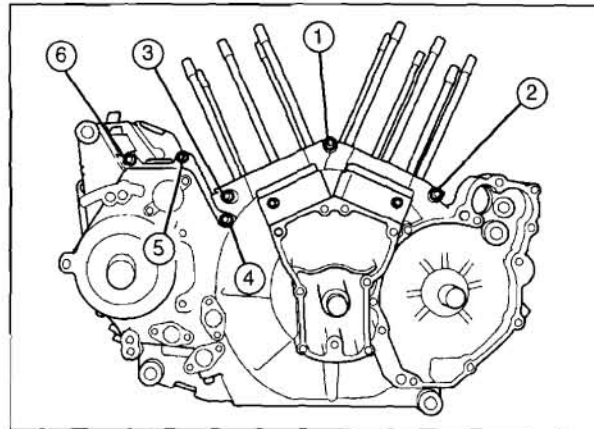
NOTE: Do not remove the push rod tubes from the crankcase. Remove only one circlip from the piston for quicker piston pin removal.

- Remove the right side crankcase bolts (three 8mm and three 6mm) only.

NOTE: Do not remove the cam cover or generator cover.

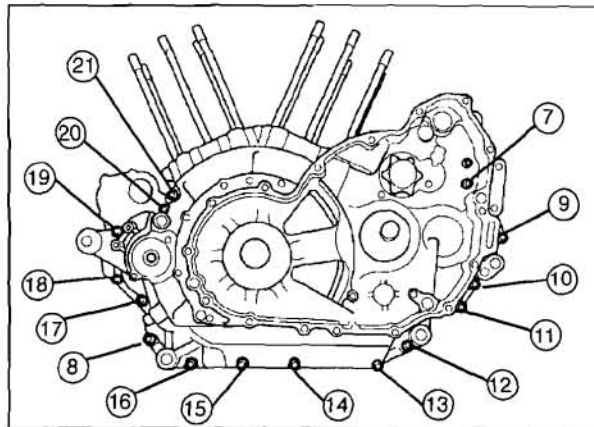
- Tilt the engine to the right and rest the cam cover against a block covered with cardboard or other protective material to protect the engine finish. Remove the left-side crankcase bolts (6mm bolts, quantity 15).
- Align the shift cam segment with the segment-shaped hole in the crankcase.
- While holding the crankshaft against the right crankcase, remove the left crankcase half.

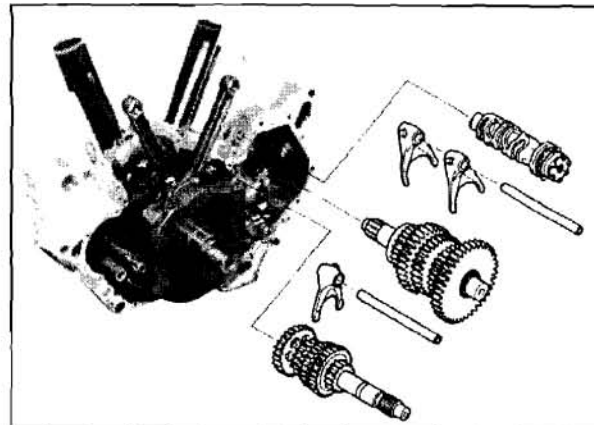
Be sure to hold the crankshaft against the right case half to prevent disengagement of the camshaft drive gear.

- Remove the shift fork shafts, shift forks, and transmission.

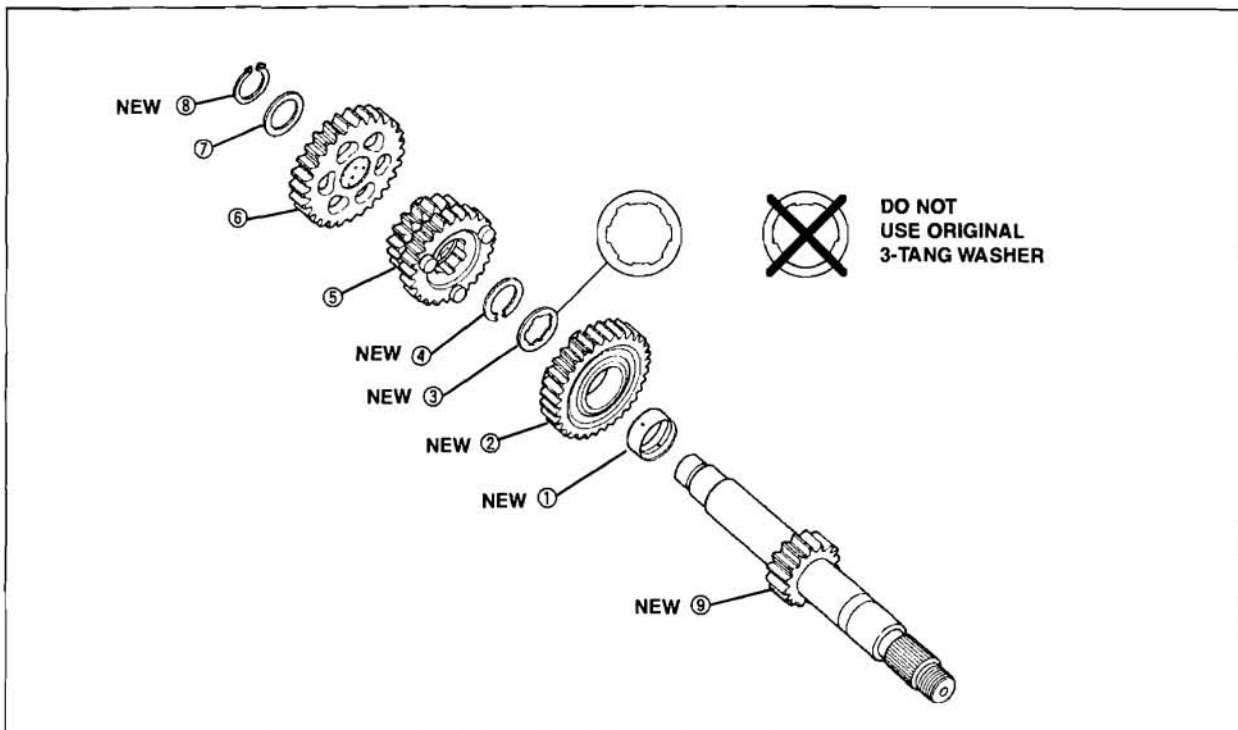
Main Shaft Modification:

- Completely disassemble the main shaft. The Washer ⑦, 5th Pinion Gear ⑥, and 2nd/3rd Pinion Gear ⑤ will be reused.
- Install the components on the new-type Main Shaft ⑨ in the following order. Lubricate all components with engine oil. Be sure circlips are installed with the sharp edge of the inner diameter facing away from the mating washer.

- ① Collar – NEW
- ② 4th Pinion Gear – NEW
- ③ Washer – NEW
- ④ Circlip – NEW
- ⑤ 2nd/3rd Pinion Gear – Reuse original part
- ⑥ 5th Pinion Gear – Reuse original part
- ⑦ Washer – Reuse original part
- ⑧ Circlip – NEW

Be sure to use all of the new parts in the kit. Otherwise, the transmission can still fail. Be sure that you are installing the new washer ③. It is thicker than the original and can be easily identified by its six tangs on the inner diameter instead of the three on the original washer.

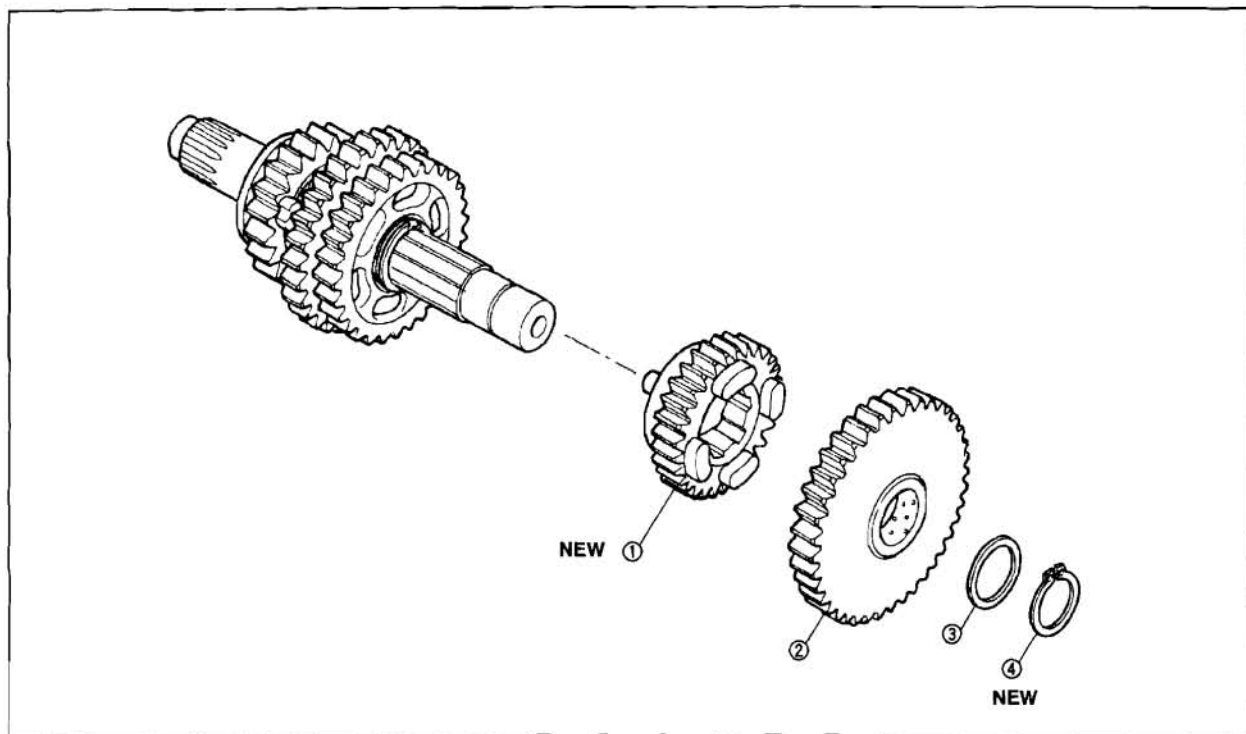
Drive Shaft Modification:

- Remove the circlip and washer from the Drive Shaft, then remove the 1st Wheel Gear and the 4th Wheel Gear. Do not disassemble the rest of the components on the shaft.
- Install the components on the original Drive Shaft in the following order. Lubricate all components with engine oil. Be sure the circlip is installed with the sharp edge of the inner diameter facing away from the mating washer.

- ① 4th Wheel Gear – NEW
- ② 1st Wheel Gear – Reuse original part
- ③ Washer – Reuse original part
- ④ Circlip – NEW

Be sure to use all of the new parts in the kit. Otherwise, the transmission can still fail.

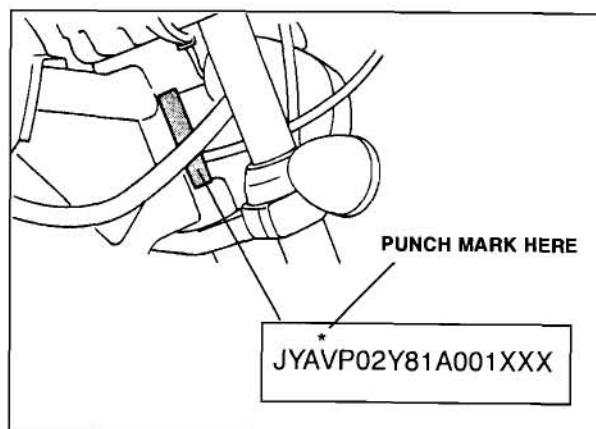
IDENTIFICATION PROCEDURE

After modifying a unit, make a punch mark above the frame number (VIN) on the steering head pipe as shown in the illustration below.
